**REBUILD ATLANTA  
ENERGY AUDITOR'S REPORT  
ATLANTA CIVIC CENTER**

Prepared: May 10, 2004  
Prepared By: Cyrus Bhedwar, City of Atlanta  
Jennifer Kiesel, Servidyne  
Jeff Ross-Bain, Southface  
Corinne Benedek, Southface  
Assisted By: Rob Lung, Department of Parks, Recreation & Cultural Affairs

**Atlanta Civic Center**  
**395 Piedmont Ave.**  
**Atlanta, Georgia 30308**

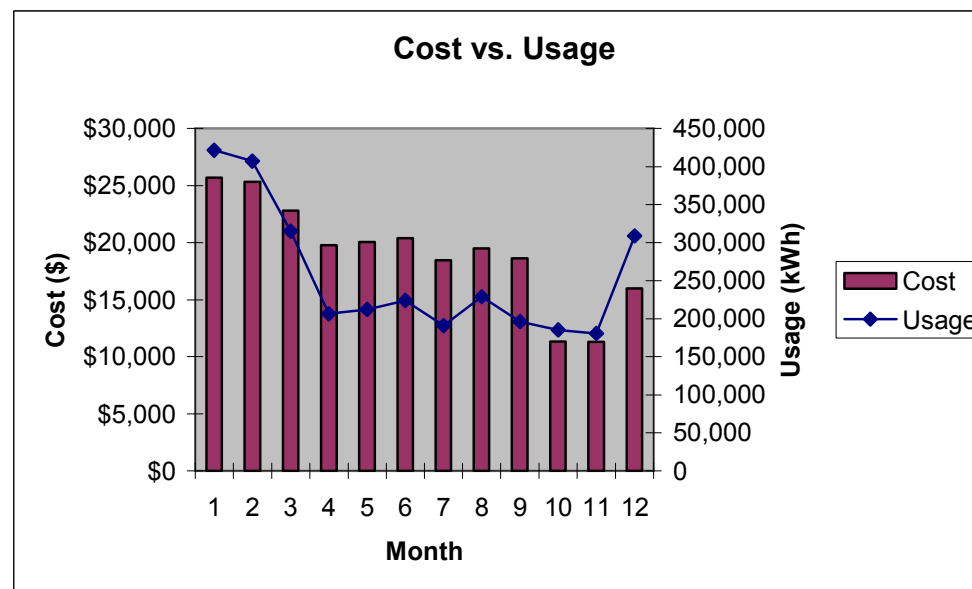
The Table on the following page shows the electricity use, cost and peak demand for the year 2003. The top graph, labeled “Cost vs. Usage” shows the relationship between electricity consumption and cost for the year 2003. The bottom graph, labeled “Cost vs. Demand” shows the relationship between cost and peak demand for the year 2003.
